5/17/94
I.1
LETTER REPORT
FOR
FORD MOTOR COMPANY/ALLEN PARK
ALLEN PARK, WAYNE COUNTY, MICHIGAN
TDD# T05-9404-027
PAN: EMI0249RAA
DOCUMENT CONTROL NO.: TAT-05-25-04060

Re: Ford Motor Company/Allen Park
Allen Park, Wayne County, Michigan
TDD # T05-9404-027
PAN EMI0249RAA

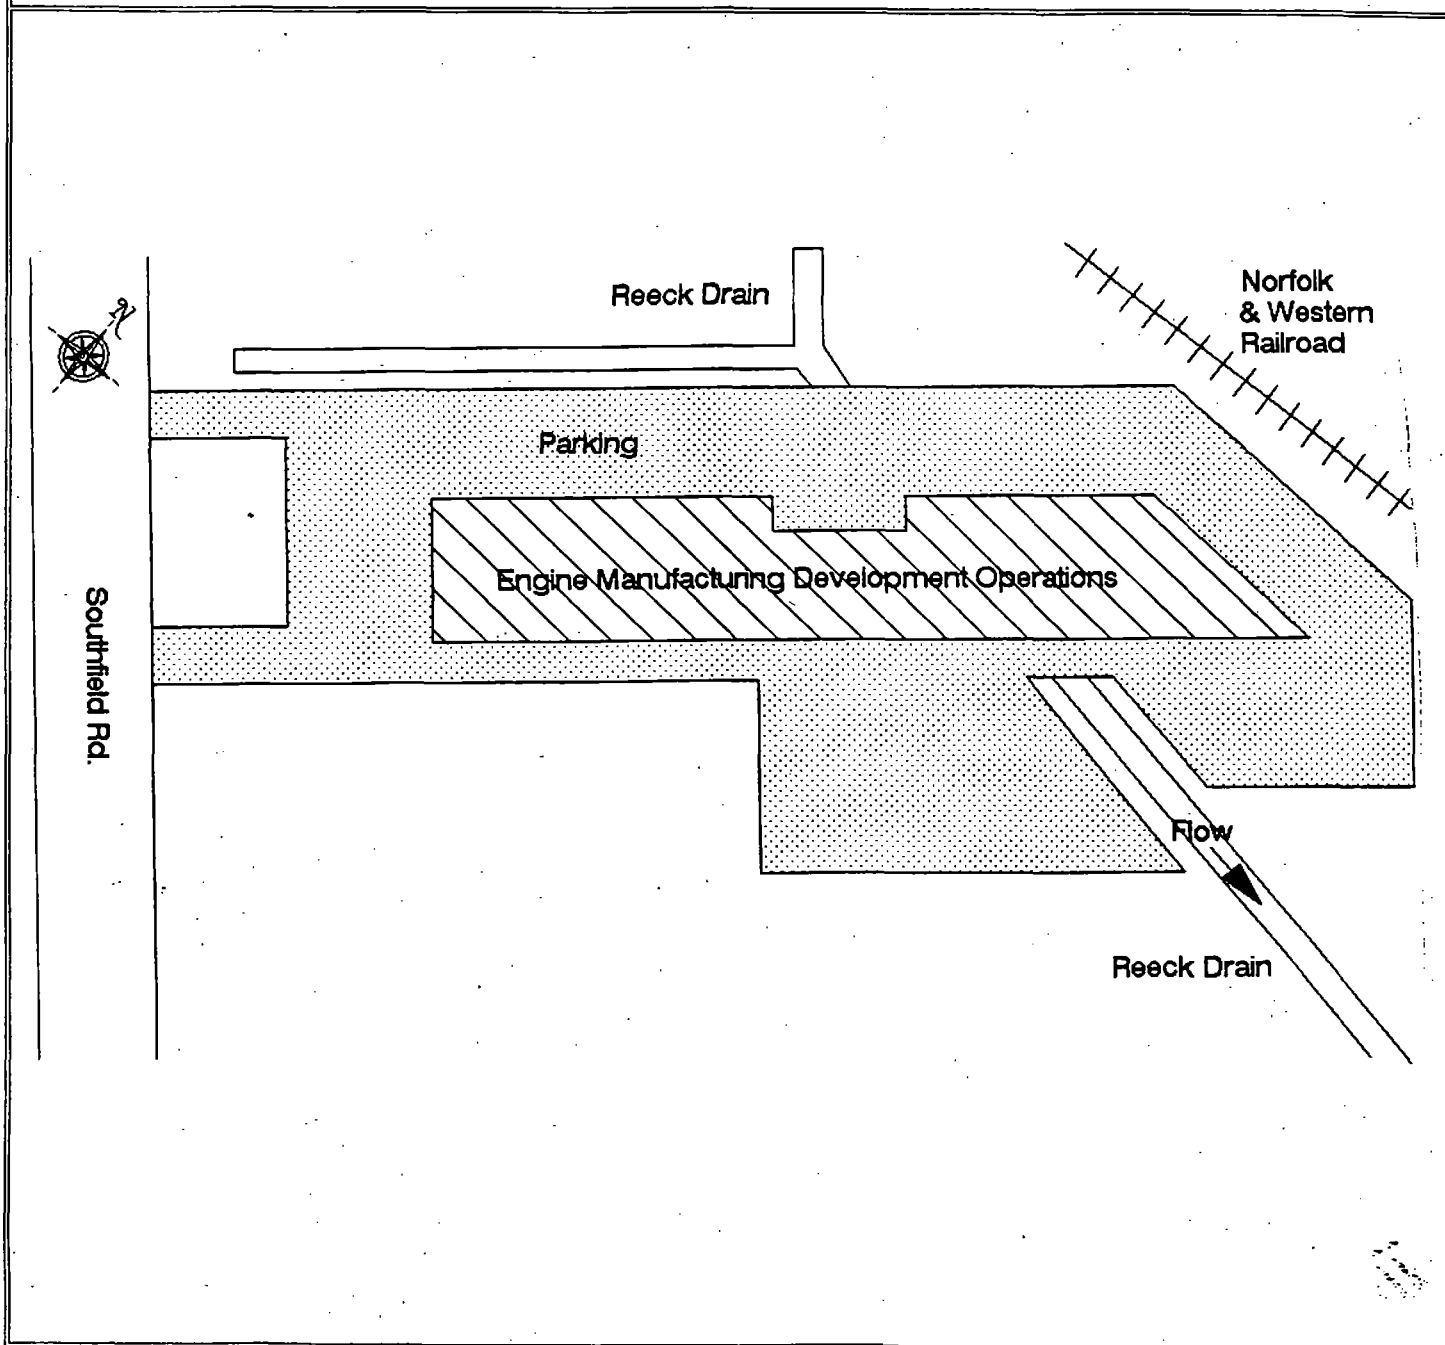
6. FIELD DRAWINGS (Attach more sheets if needed, and show north arrow of other orientation)

Emergency phone numbers relating to the U.S. EPA are out of date or improperly identified.
